# Desert Environment Effect on the Deterioration of Ancient Building Materials in Archaeological Buildings (El- Bagawat Tombs, El - Kharga Oasis as an Example)

## **Abstract:**

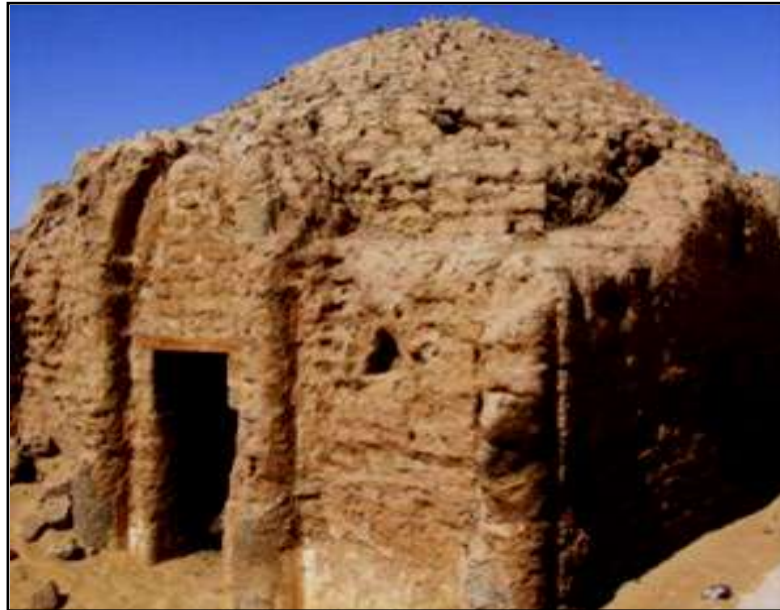
The wind carries many materials like sand, dust and pollen grains, when it hits any building, it causes the erosion, especially facades and deposits these materials outside the building, mud brick is a weak building material so the wind causes the severe erosion of it and deposits sand inside and outside the tombs, the same situation applies on mud mortar, figure (10- 15).

**Figure 10.** Wind's erosion of mud bricks at El-Bagawat tombs

Environment has a severe effect on the deterioration of archaeological buildings and sites, there are agricultural, marine and desert effect (1, 2, 3, and 4). El-Bagawat tombs from the early Coptic era suffer from desert environmental effect on the deterioration of their building materials like: mud bricks (essential building material) and mud mortar (secondary building material), not only these materials but also wall paintings layers and pigments inside them, so environmental effect is an important phenomenon deserves to be studied at El-Kharga oasis, desert environment deterioration factors threaten this precious cultural heritage. The researchers recommend cultivating trees around the borders of the tombs to work as bumpers because wind is the main deterioration factor of the desert environment, by this way, tombs facades will be preserved from wind erosion.

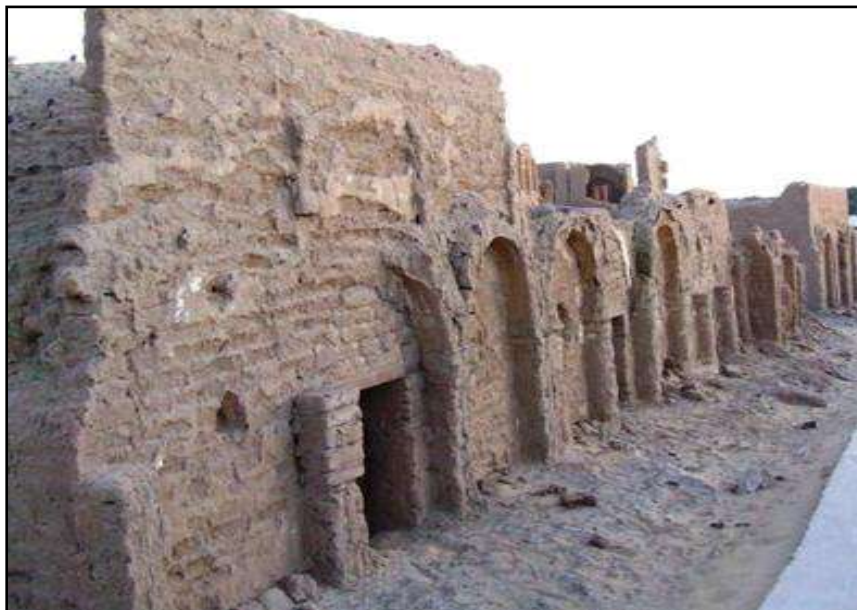
**Figure 11.** Wind's erosion of tombs façade and weakness of mud bricks

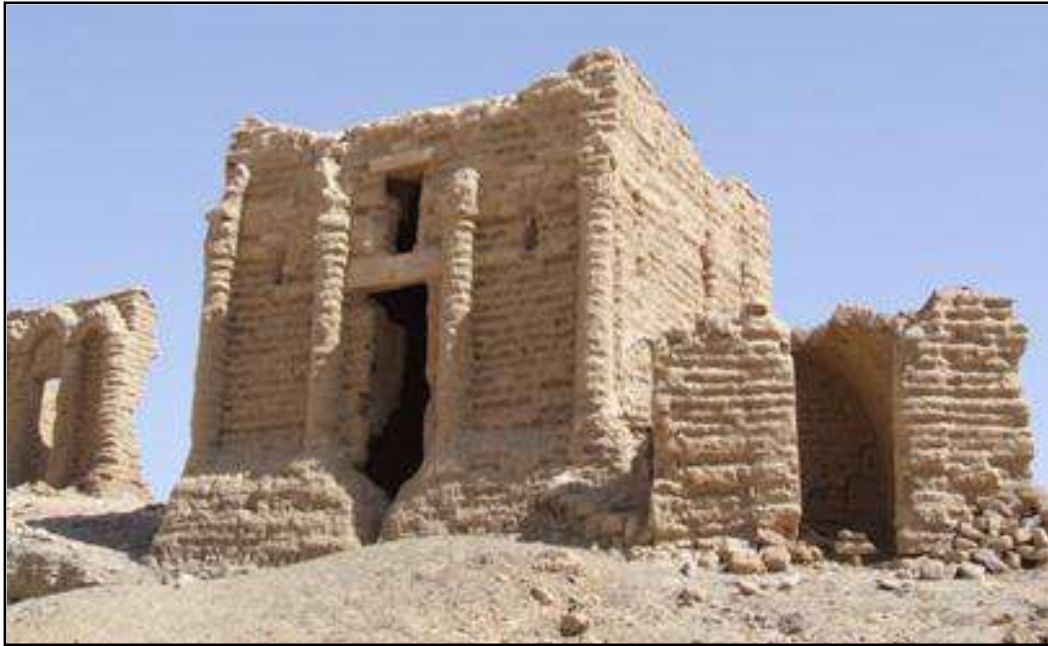
**Figure 12.** Tombs façade weakness due to wind erosion

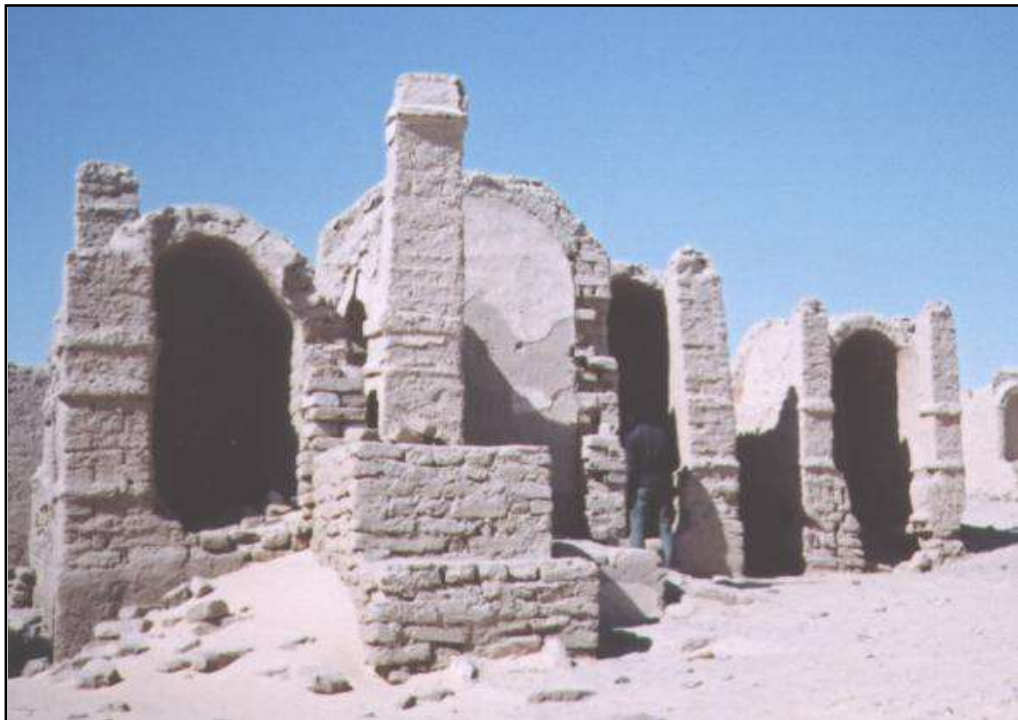
**Figure 13.** Sand deposits outside the tombs due to the wind

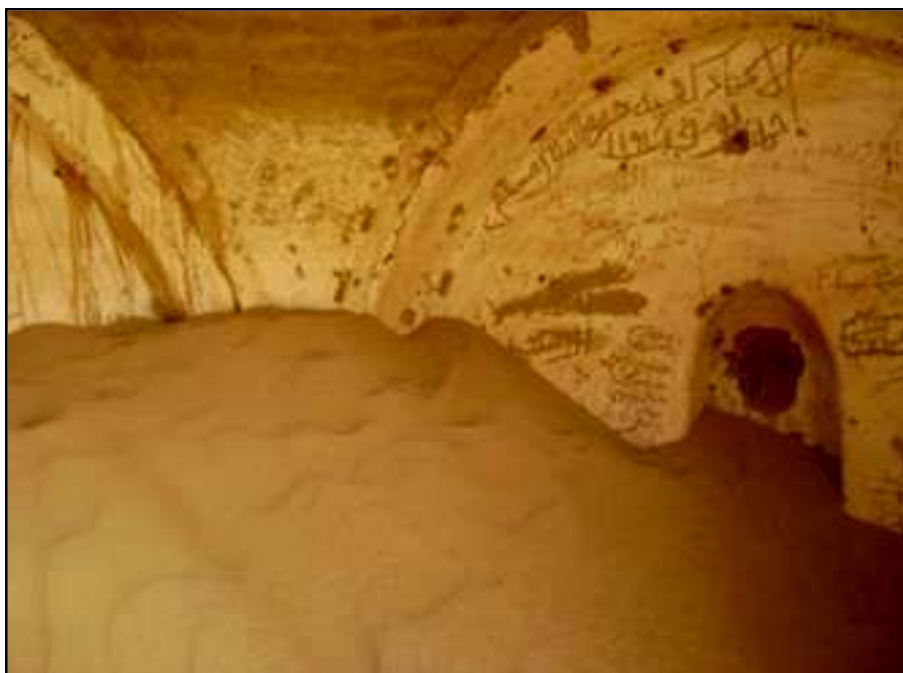
**Figure 14.** Heavy sand deposits inside the tombs due to the wind

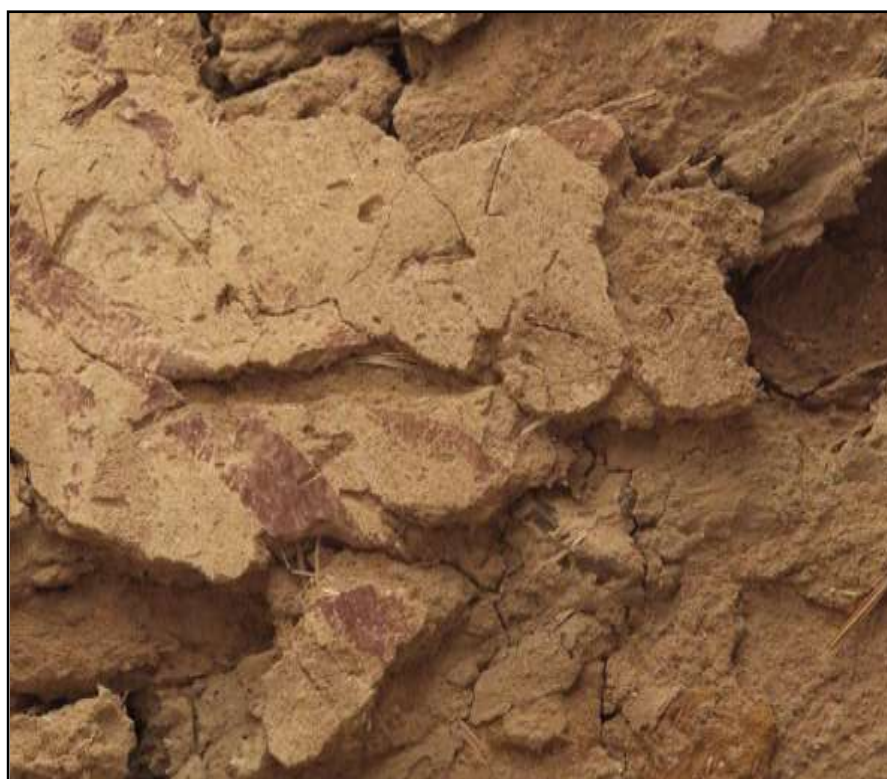
It was noticed From the previous results that desert environment effect is physical, it doesn't affect chemically on the components of building materials , air temperature variation cooperates with wind and relative humidity to weaken the building materials at El-Bagawat tombs, the big difference between air temperature degrees daily and seasonally causes cracks

and exfoliation of mud bricks and mortars, mud bricks are low conductivity materials , they absorb heat during the day, it leads to minerals expanding and their shrinkage at the night, the expanding and shrinkage rates differ from mineral to the other, the result is many cracks in the mud bricks and mortar.

**Figure 15.** Mud bricks weakness and cracking due to air temperature variation
